# Uniform Mitigation Verification Inspection Form

| Address: 10101-10204 L 'Pavia Boulevard | | Home Phone: |

**10101-10204 L 'Pavia Boulevard**  
Project #24RS-0511  
March 12, 2025  
Page 1 of 4

**UNIFORM MITIGATION VERIFICATION INSPECTION FORM  
SUPPLEMENTARY FIGURES & DOCUMENTATION**

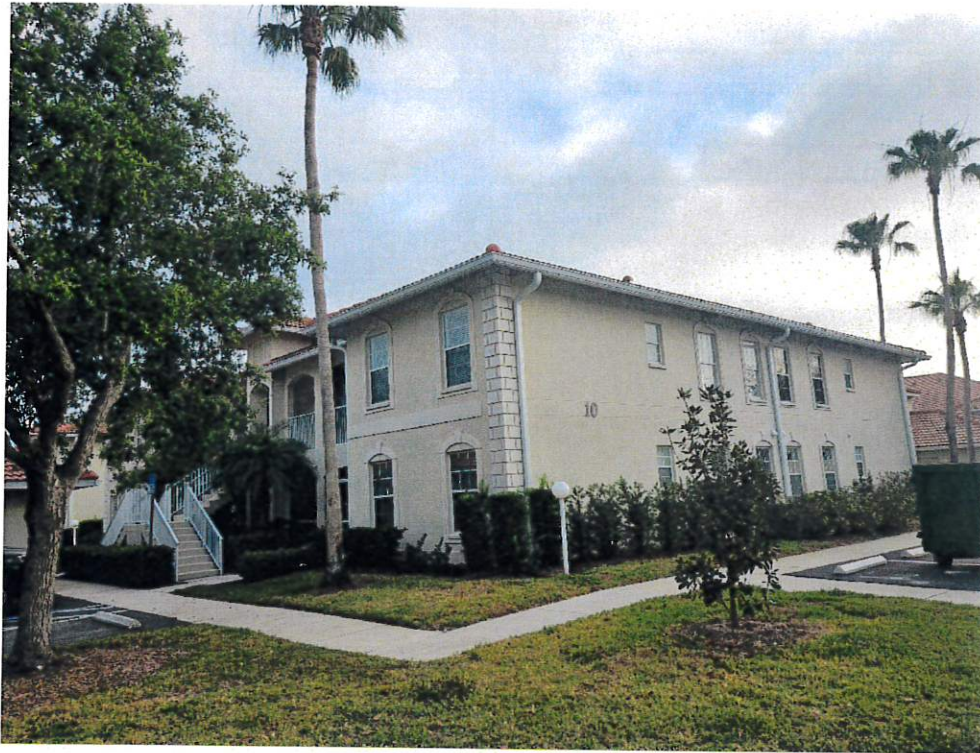
Figure 1: Roof Type (Concrete Barrel Tile) and Geometry (Hip)

| 2.1 Roof Covering Type: | Permit Application Date | FBC or MDC Product Approval # | Year of Original Installation or Replacement | No Information Provided for Compliance |
|---|---|---|---|---|
| <input checked="" type="checkbox"/> 2. Concrete/Clay Tile | <u>12 / 19 / 2024</u> | <u>MDC #25-0127.09</u> | <u>2025</u> | <input type="checkbox"/> |

- ☒ A. Hip Roof Hip roof with no other roof shapes greater than 10% of the total roof system perimeter.  
Total length of non-hip features: 0 feet; Total roof system perimeter: ~336 feet
- ☐ B. Flat Roof Roof on a building with 5 or more units where at least 90% of the main roof area has a roof slope of less than 2:12. Roof area with slope less than 2:12 \_\_\_\_\_ sq ft; Total roof area \_\_\_\_\_ sq ft
- ☐ C. Other Roof Any roof that does not qualify as either (A) or (B) above.

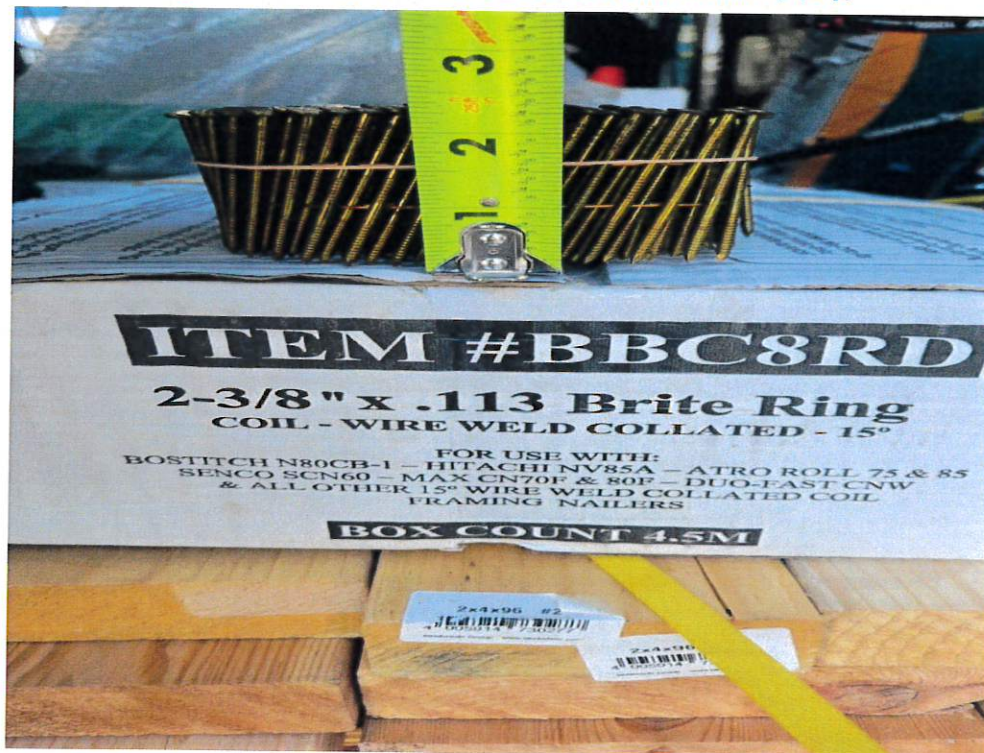
Figure 2 - Roof Deck Attachment

- ☒ C. Plywood/OSB roof sheathing with a minimum thickness of 7/16" inch attached to the roof truss/rafter (spaced a maximum of 24" inches o.c.) by 8d common nails spaced a maximum of 6" inches in the field. -OR- Dimensional lumber/Tongue & Groove decking with a minimum of 2 nails per board (or 1 nail per board if each board is equal to or less than 6 inches in width). -OR- Any system of screws, nails, adhesives, other deck fastening system or truss/rafter spacing that is shown to have an equivalent

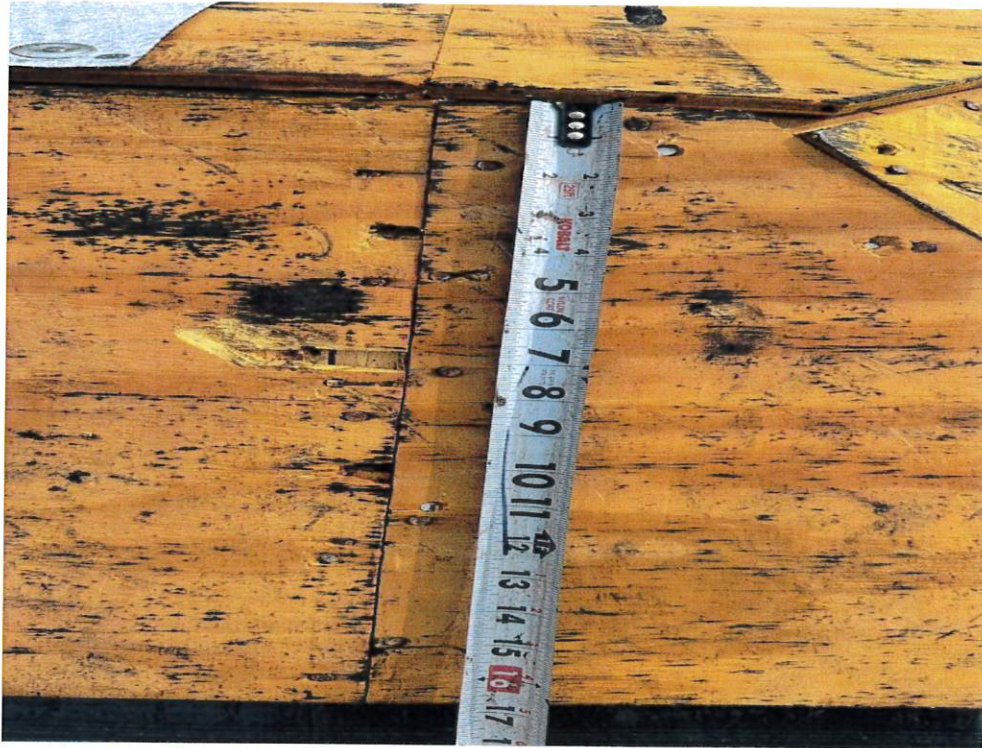
Figure 3 – Sheathing Fastener Spacing

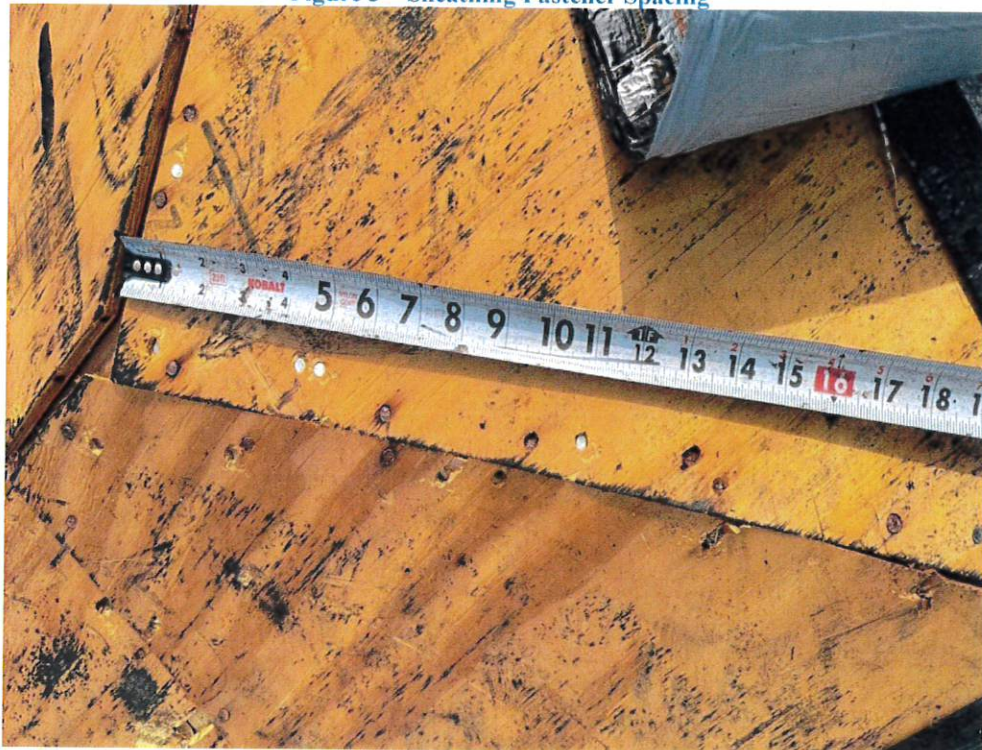
Figure 4 – Sheathing Edge Fastener Edge Spacing

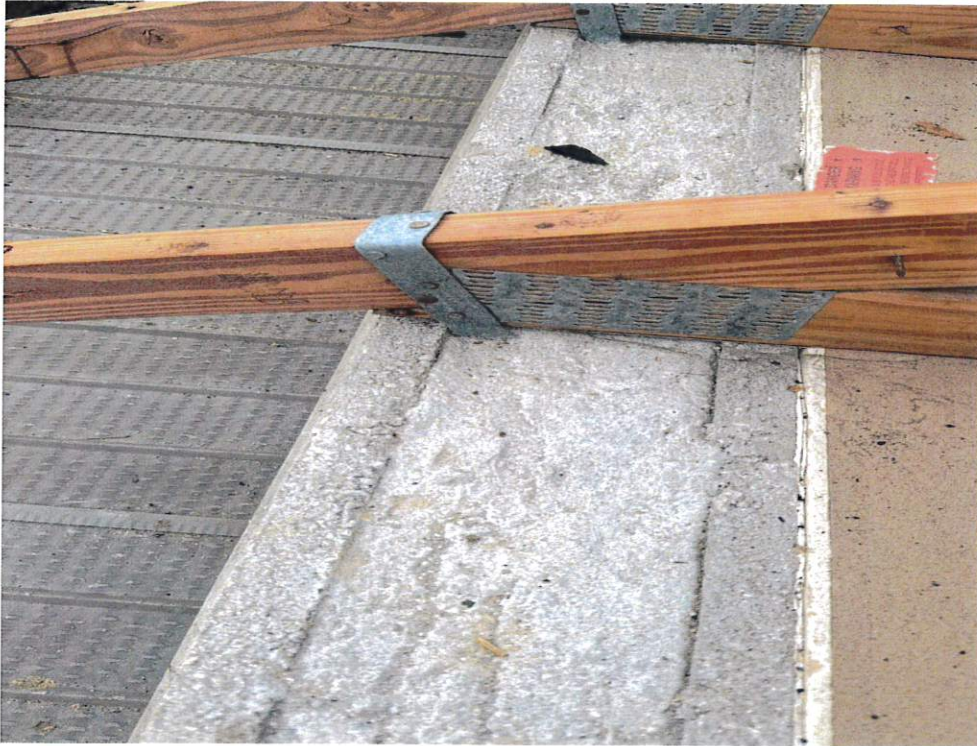
Figure 5 – Roof to Wall Attachment

- ☒ C. Single Wraps
  - Metal connectors consisting of a single strap that wraps over the top of the truss/rafter and is secured with a minimum of 2 nails on the front side and a minimum of 1 nail on the opposing side.

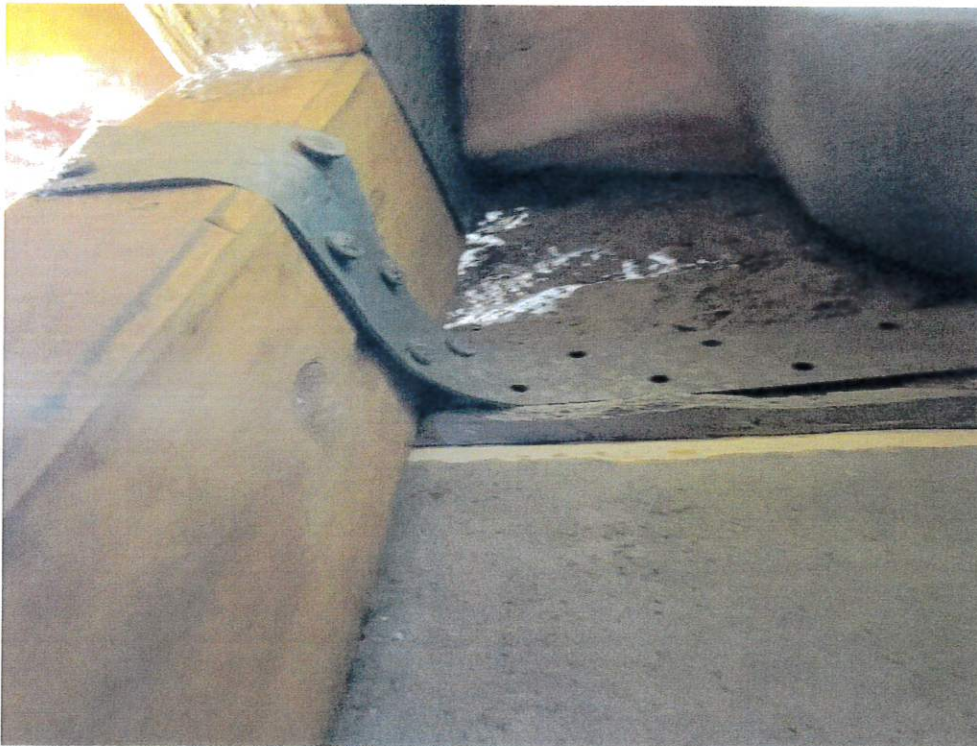
Figure 6 - Roof to Wall Attachment

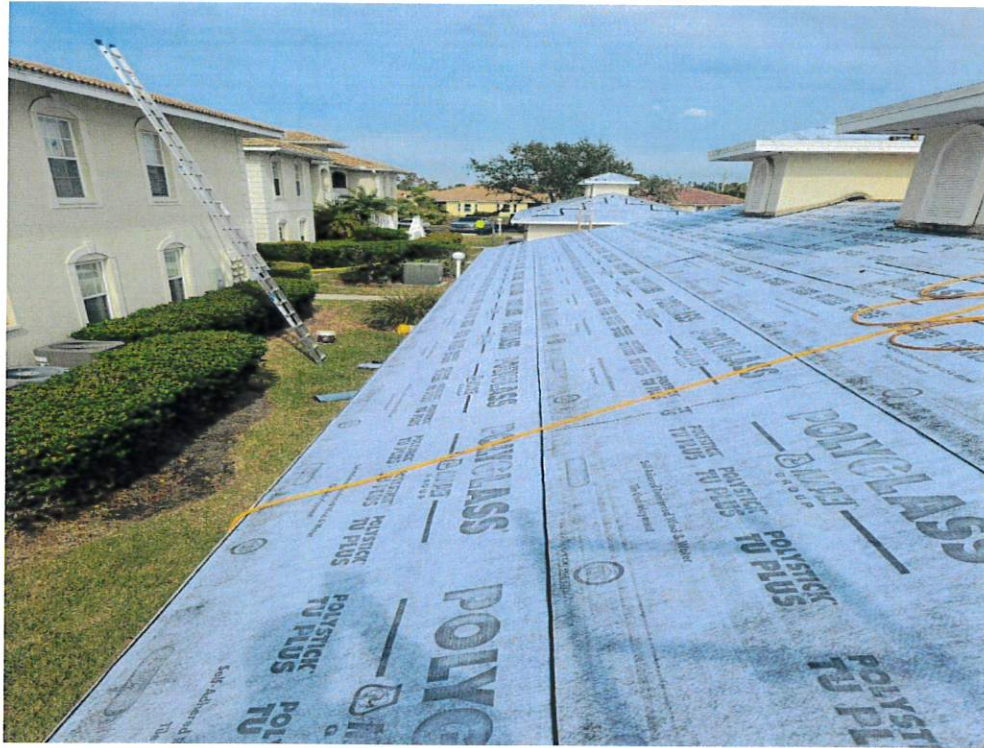
Figure 7 – Secondary Water Resistance

- ☒ A. SWR (also called Sealed Roof Deck) Self-adhering polymer modified-bitumen roofing underlayment applied directly to the sheathing or foam adhesive SWR barrier (not foamed-on insulation) applied as a supplemental means to protect the dwelling from water intrusion in the event of roof covering loss.
- ☐ B. No SWR.
- ☐ C. Unknown or undetermined.
