# Uniform Mitigation Verification Inspection Form

| Address: 1101-1204 L 'Pavia Boulevard - Garage 2 | | Home Phone: |

**1101-1204 L Pavia Boulevard – Garage 2**  
Project #24RS-0511  
March 12, 2025  
Page 1 of 4

**UNIFORM MITIGATION VERIFICATION INSPECTION FORM  
SUPPLEMENTARY FIGURES & DOCUMENTATION**

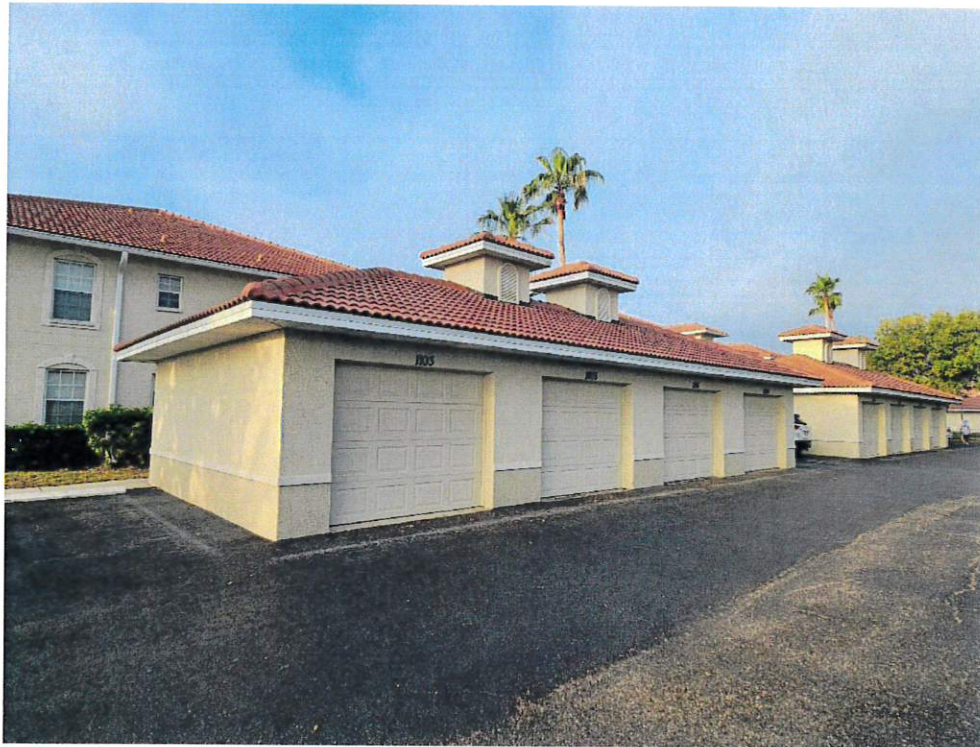
Figure 1: Roof Type (Concrete Barrel Tile) and Geometry (Hip)

| 2.1 Roof Covering Type: | Permit Application Date | FBC or MDC Product Approval # | Year of Original Installation or Replacement | No Information Provided for Compliance |
|---|---|---|---|---|
| <input checked="" type="checkbox"/> 2. Concrete/Clay Tile | <u>12 / 18 / 2024</u> | <u>MDC #25-0127.09</u> | <u>2025</u> | <input type="checkbox"/> |

- ☒ A. Hip Roof Hip roof with no other roof shapes greater than 10% of the total roof system perimeter.  
Total length of non-hip features: 0 feet; Total roof system perimeter: ~162 feet
- ☐ B. Flat Roof Roof on a building with 5 or more units where at least 90% of the main roof area has a roof slope of less than 2:12. Roof area with slope less than 2:12 \_\_\_\_\_ sq ft; Total roof area \_\_\_\_\_ sq ft
- ☐ C. Other Roof Any roof that does not qualify as either (A) or (B) above.

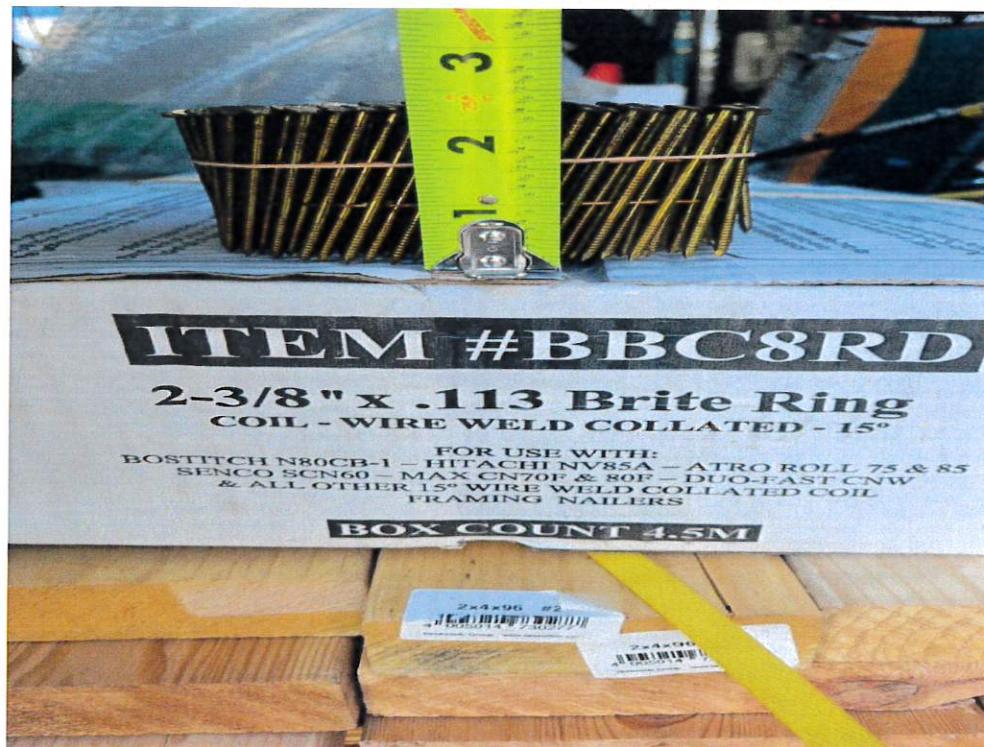
Figure 2 - Roof Deck Attachment

- ☒ C. Plywood/OSB roof sheathing with a minimum thickness of 7/16" inch attached to the roof truss/rafter (spaced a maximum of 24" inches o.c.) by 8d common nails spaced a maximum of 6" inches in the field. -OR- Dimensional lumber/Tongue & Groove decking with a minimum of 2 nails per board (or 1 nail per board if each board is equal to or less than 6 inches in width). -OR- Any system of screws, nails, adhesives, other deck fastening system or truss/rafter spacing that is shown to have an equivalent

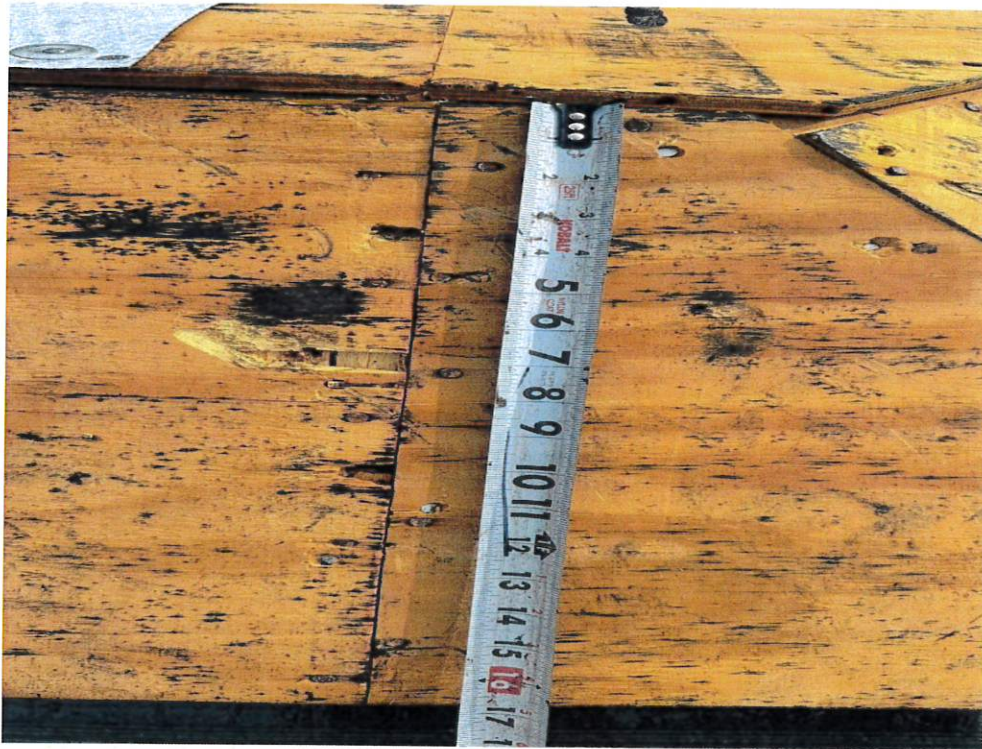
Figure 3 – Sheathing Fastener Spacing

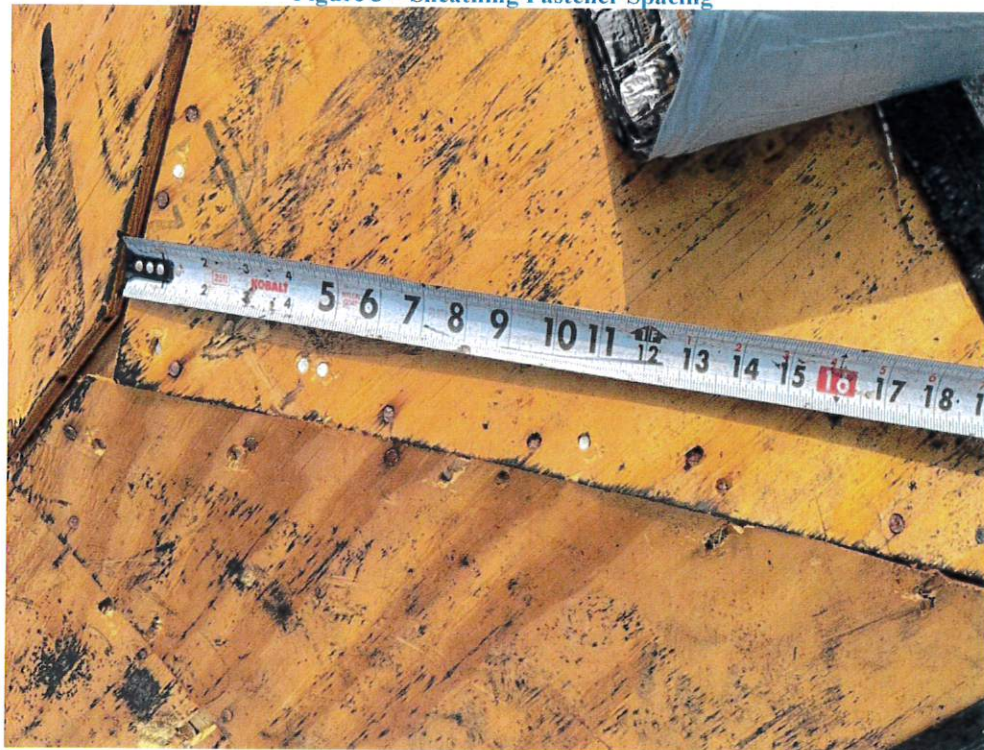
Figure 4 – Sheathing Edge Fastener Edge Spacing

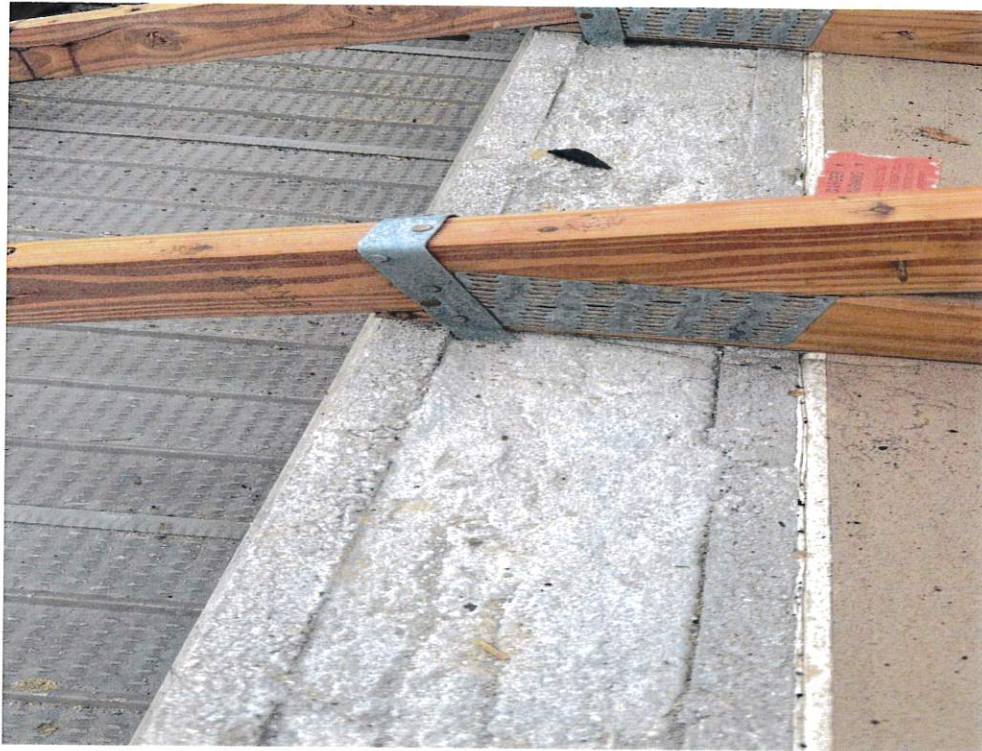
**Figure 5 – Roof to Wall Attachment**

- ☒ C. Single Wraps
  - Metal connectors consisting of a single strap that wraps over the top of the truss/rafter and is secured with a minimum of 2 nails on the front side and a minimum of 1 nail on the opposing side.

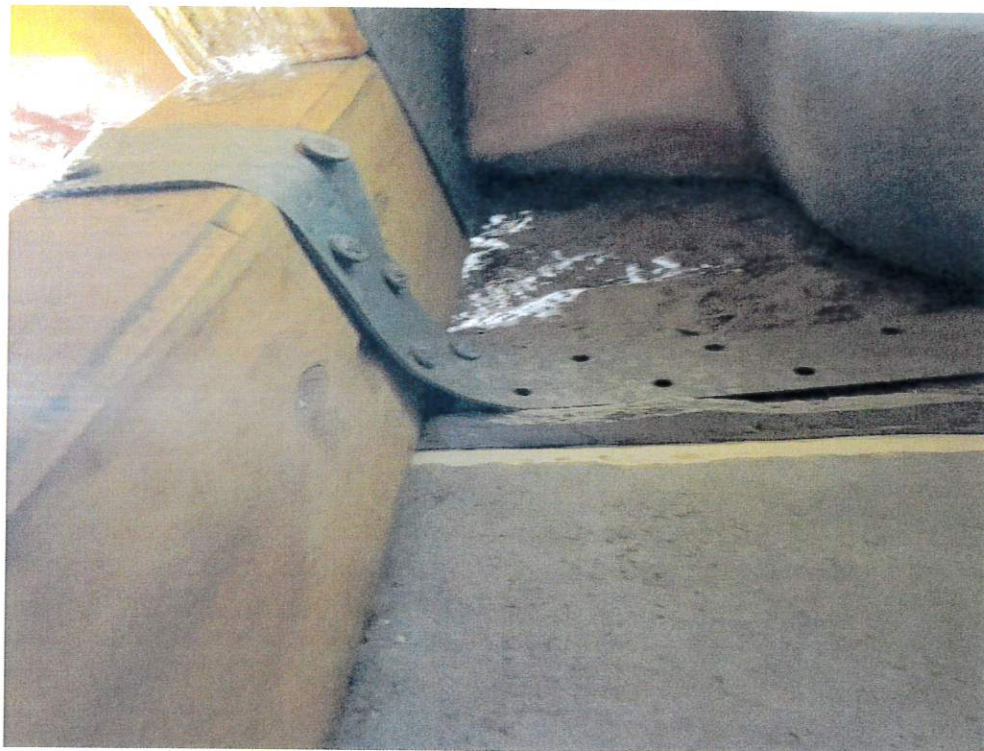
**Figure 6 - Roof to Wall Attachment**

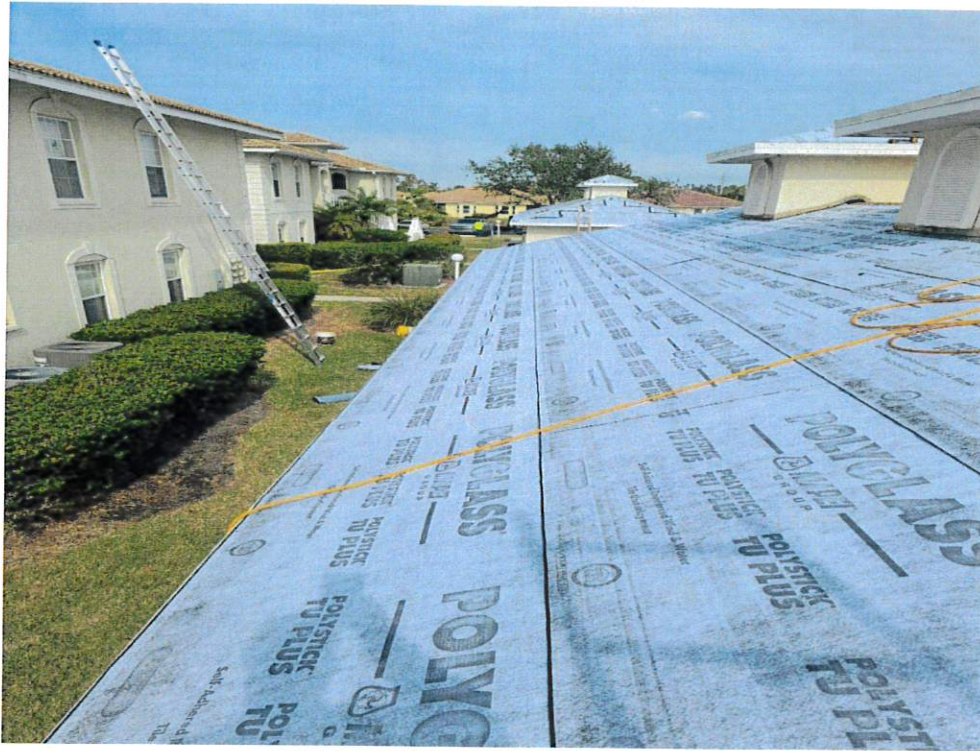
Figure 7 – Secondary Water Resistance

- ☒ A. SWR (also called Sealed Roof Deck) Self-adhering polymer modified-bitumen roofing underlayment applied directly to the sheathing or foam adhesive SWR barrier (not foamed-on insulation) applied as a supplemental means to protect the dwelling from water intrusion in the event of roof covering loss.
- ☐ B. No SWR.
- ☐ C. Unknown or undetermined.
