# Uniform Mitigation Verification Inspection Form

| Owner Name: L 'Pavia Condominium Association, Inc. | | Contact Person: |
| Address: 6101-6204 L 'Pavia Boulevard | | Home Phone: |

**UNIFORM MITIGATION VERIFICATION INSPECTION FORM  
SUPPLEMENTARY FIGURES & DOCUMENTATION**

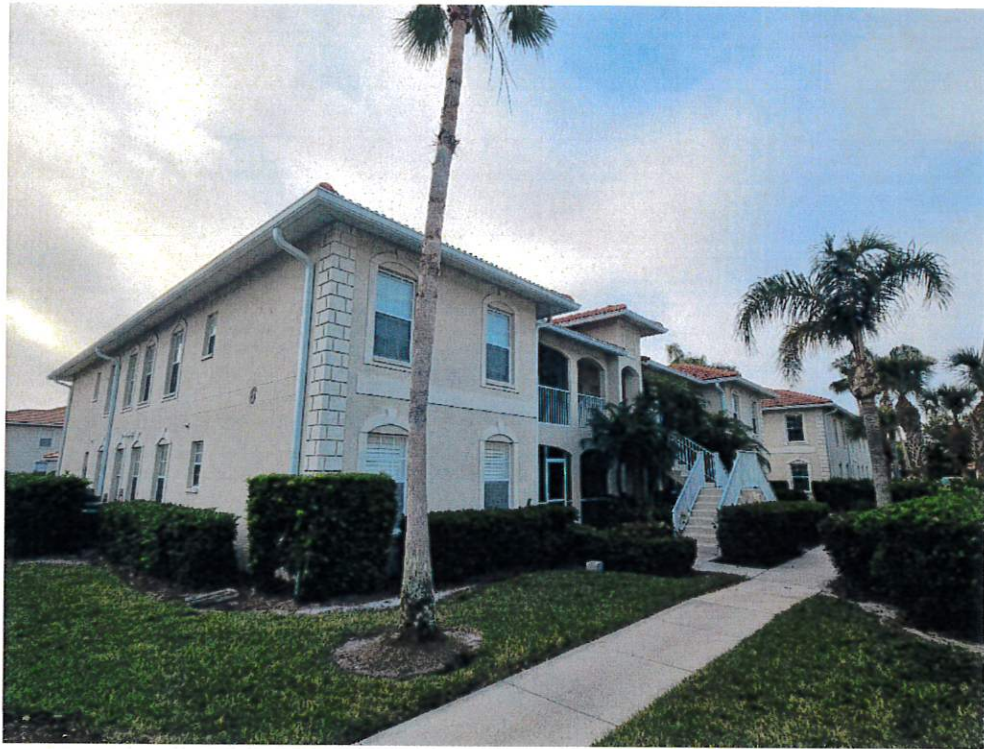
| 2.1 Roof Covering Type: | Permit Application Date | FBC or MDC Product Approval # | Year of Original Installation or Replacement | No Information Provided for Compliance |
|---|---|---|---|---|
| <input checked="" type="checkbox"/> 2. Concrete/Clay Tile | <u>12 / 19 / 2024</u> | <u>MDC #25-0127.09</u> | <u>2025</u> | <input type="checkbox"/> |

- ☒ A. Hip Roof Hip roof with no other roof shapes greater than 10% of the total roof system perimeter.  
Total length of non-hip features: 0 \_\_\_\_\_ feet; Total roof system perimeter: ~336 \_\_\_\_\_ feet
- ☐ B. Flat Roof Roof on a building with 5 or more units where at least 90% of the main roof area has a roof slope of less than 2:12. Roof area with slope less than 2:12 \_\_\_\_\_ sq ft; Total roof area \_\_\_\_\_ sq ft
- ☐ C. Other Roof Any roof that does not qualify as either (A) or (B) above.

Figure 1: Roof Type (Concrete Barrel Tile) and Geometry (Hip)

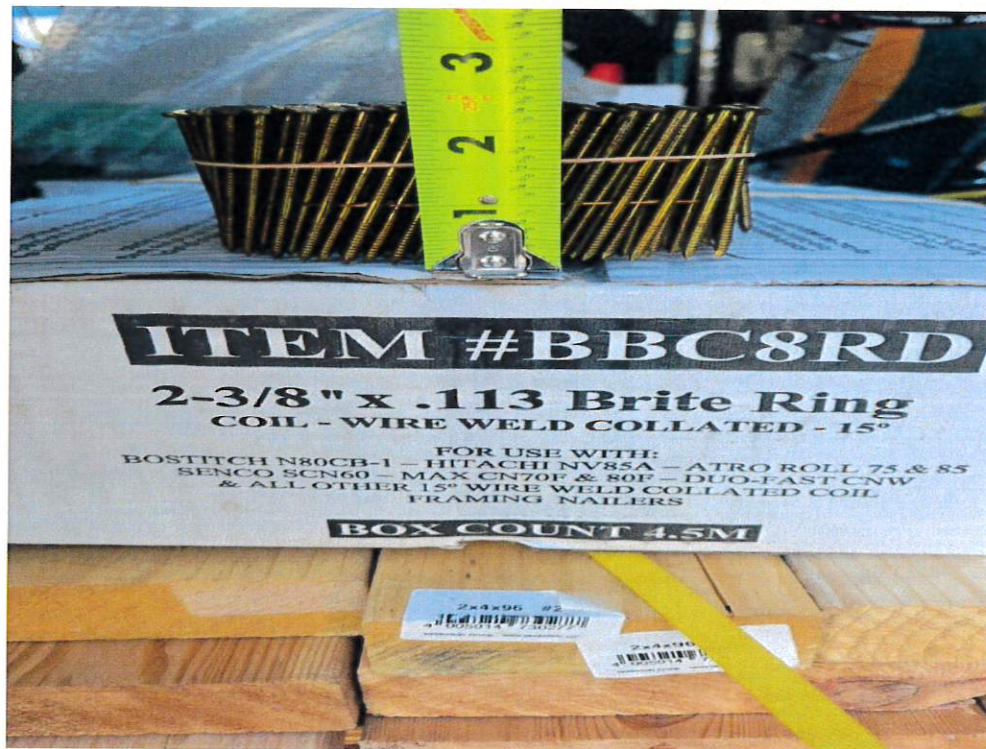
- ☒ C. Plywood/OSB roof sheathing with a minimum thickness of 7/16" inch attached to the roof truss/rafter (spaced a maximum of 24" inches o.c.) by 8d common nails spaced a maximum of 6" inches in the field. -OR- Dimensional lumber/Tongue & Groove decking with a minimum of 2 nails per board (or 1 nail per board if each board is equal to or less than 6 inches in width). -OR- Any system of screws, nails, adhesives, other deck fastening system or truss/rafter spacing that is shown to have an equivalent

Figure 2 - Roof Deck Attachment

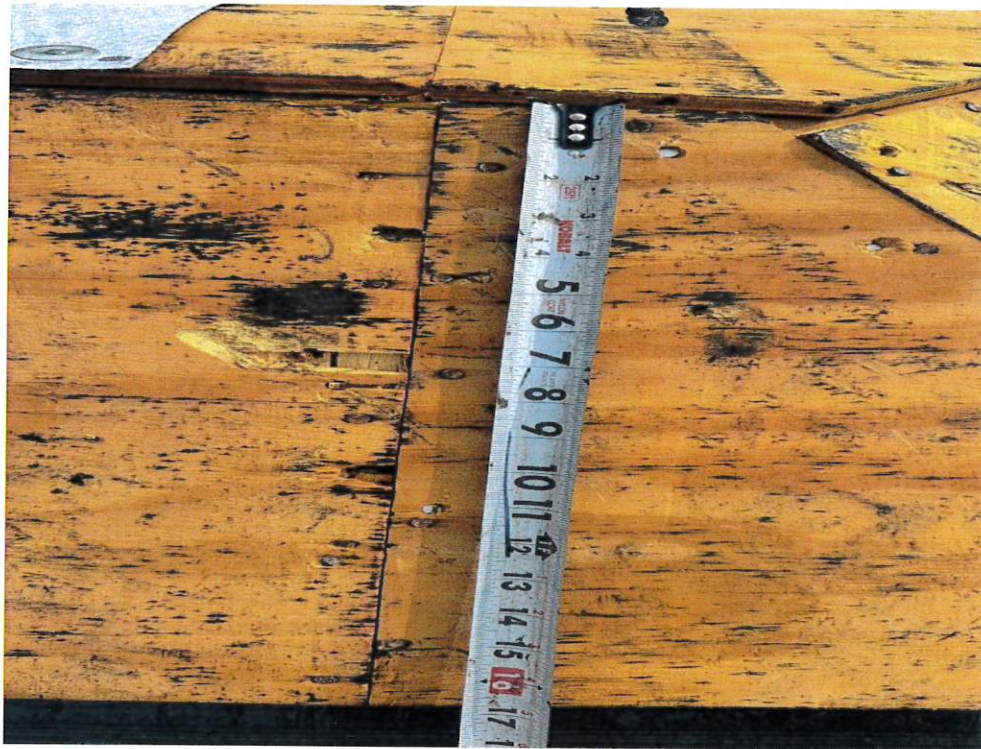
Figure 3 – Sheathing Fastener Spacing

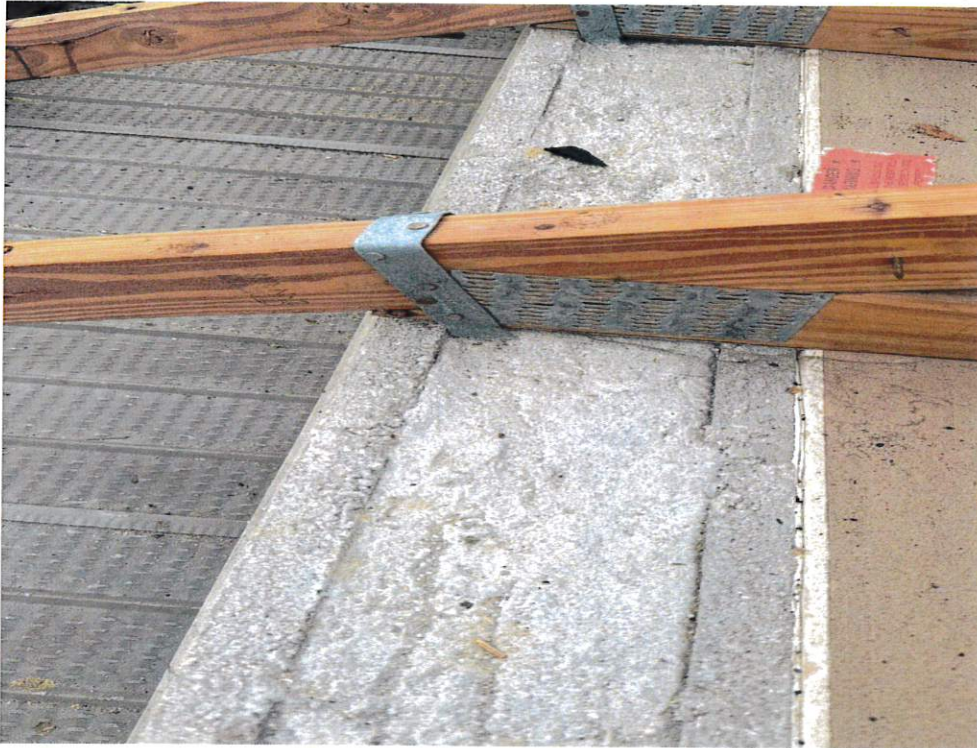
- ☒ C. Single Wraps
  - Metal connectors consisting of a single strap that wraps over the top of the truss/rafter and is secured with a minimum of 2 nails on the front side and a minimum of 1 nail on the opposing side.

Figure 5 – Roof to Wall Attachment

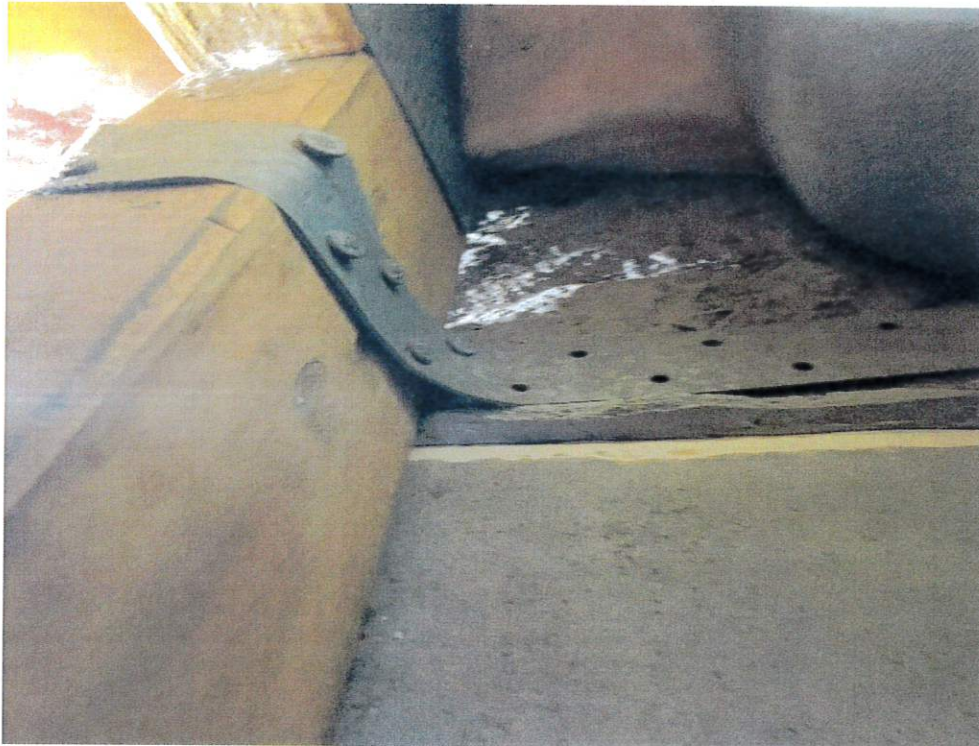
Figure 6 - Roof to Wall Attachment

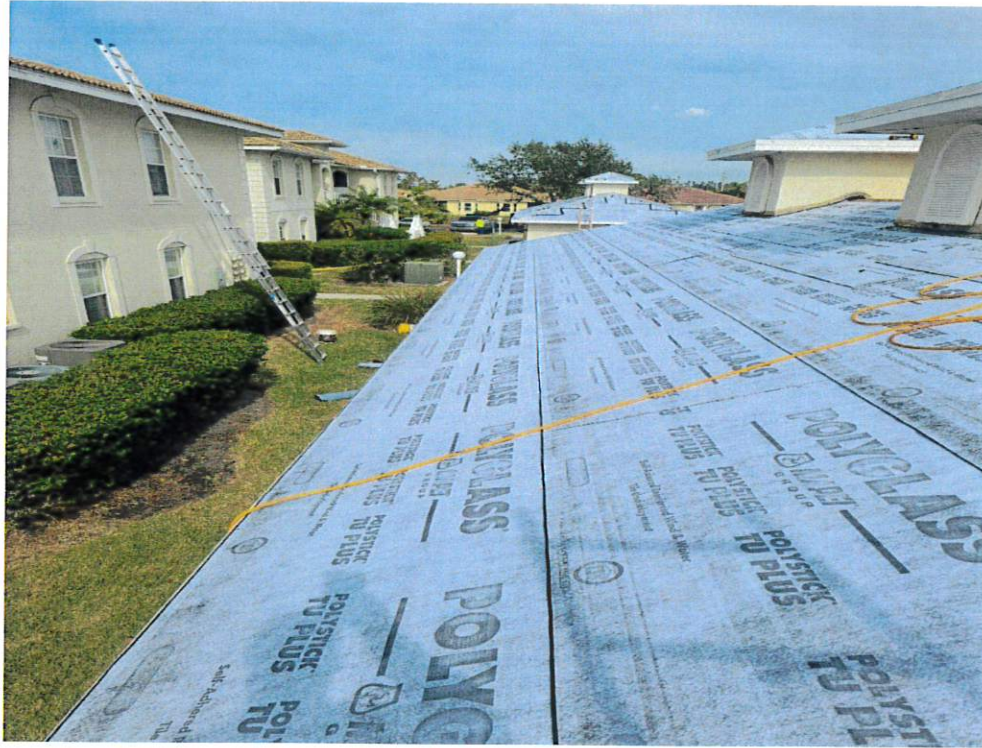
- ☒ A. SWR (also called Sealed Roof Deck) Self-adhering polymer modified-bitumen roofing underlayment applied directly to the sheathing or foam adhesive SWR barrier (not foamed-on insulation) applied as a supplemental means to protect the dwelling from water intrusion in the event of roof covering loss.
- ☐ B. No SWR.
- ☐ C. Unknown or undetermined.

Figure 7 – Secondary Water Resistance
