# Uniform Mitigation Verification Inspection Form

| Address: 9101-9204 L 'Pavia Boulevard - Garage 1 | | Home Phone: |

**9101-9204 L 'Pavia Boulevard – Garage 1**  
Project #24RS-0511  
March 12, 2025  
Page 1 of 4

**UNIFORM MITIGATION VERIFICATION INSPECTION FORM  
SUPPLEMENTARY FIGURES & DOCUMENTATION**

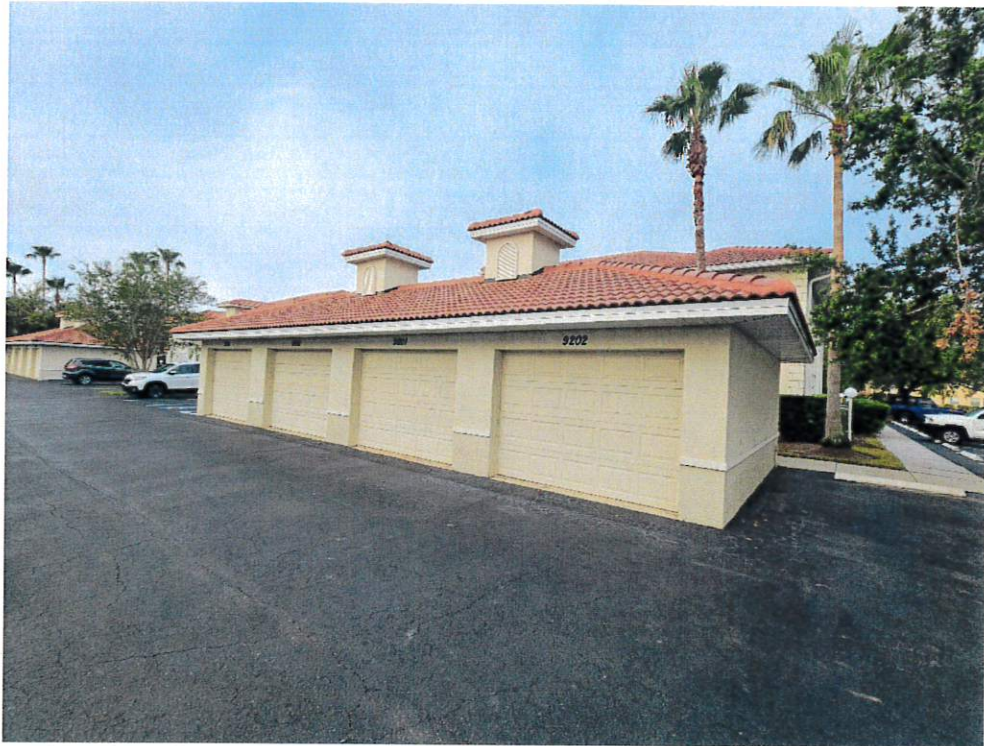
Figure 1: Roof Type (Concrete Barrel Tile) and Geometry (Hip)

| 2.1 Roof Covering Type: | Permit Application Date | FBC or MDC Product Approval # | Year of Original Installation or Replacement | No Information Provided for Compliance |
|---|---|---|---|---|
| <input checked="" type="checkbox"/> 2. Concrete/Clay Tile | <u>12 / 19 / 2024</u> | <u>MDC #25-0127.09</u> | <u>2025</u> | <input type="checkbox"/> |

- ☒ A. Hip Roof Hip roof with no other roof shapes greater than 10% of the total roof system perimeter.  
Total length of non-hip features: 0 feet; Total roof system perimeter: ~162 feet
- ☐ B. Flat Roof Roof on a building with 5 or more units where at least 90% of the main roof area has a roof slope of less than 2:12. Roof area with slope less than 2:12 \_\_\_\_\_ sq ft; Total roof area \_\_\_\_\_ sq ft
- ☐ C. Other Roof Any roof that does not qualify as either (A) or (B) above.

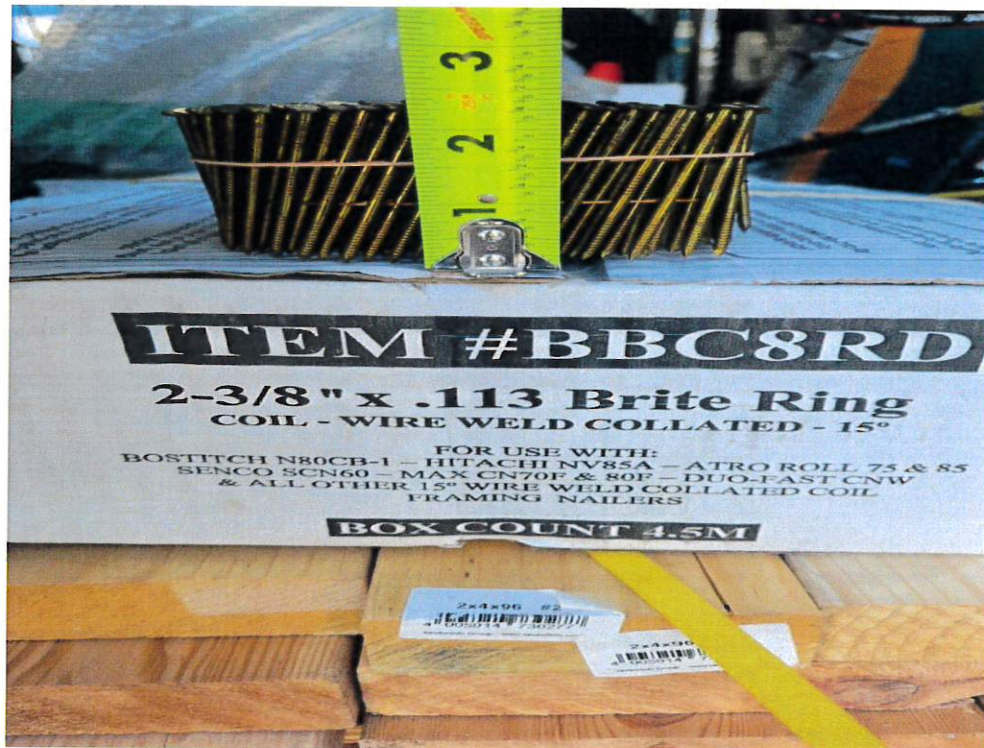
Figure 2 - Roof Deck Attachment

- ☒ C. Plywood/OSB roof sheathing with a minimum thickness of 7/16" inch attached to the roof truss/rafter (spaced a maximum of 24" inches o.c.) by 8d common nails spaced a maximum of 6" inches in the field. -OR- Dimensional lumber/Tongue & Groove decking with a minimum of 2 nails per board (or 1 nail per board if each board is equal to or less than 6 inches in width). -OR- Any system of screws, nails, adhesives, other deck fastening system or truss/rafter spacing that is shown to have an equivalent

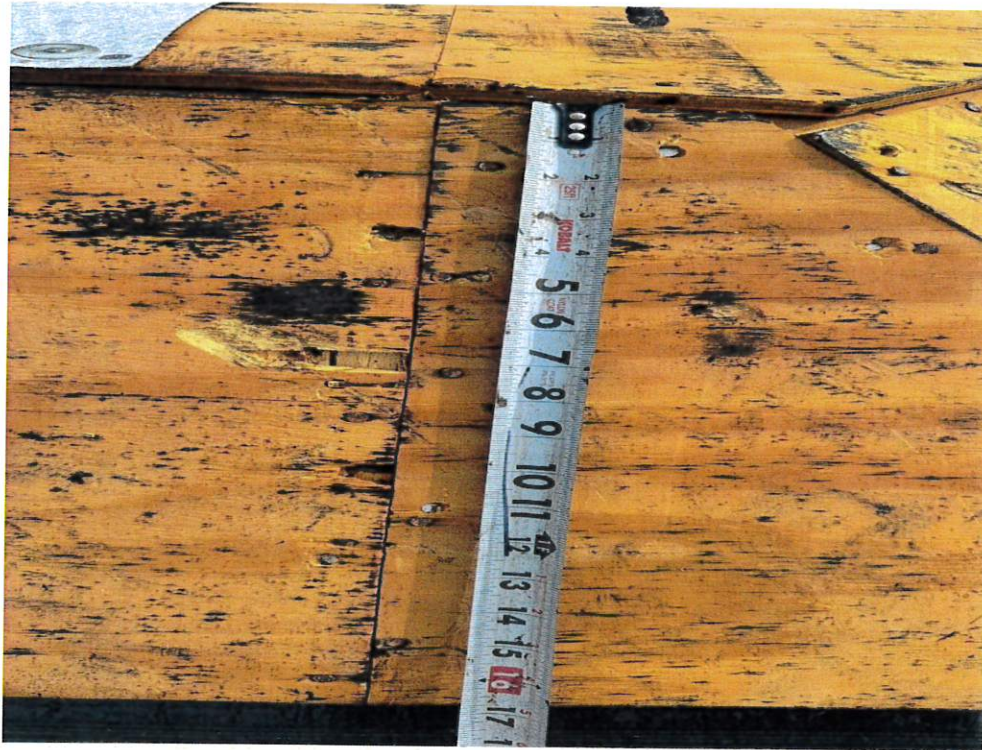
Figure 3 – Sheathing Fastener Spacing

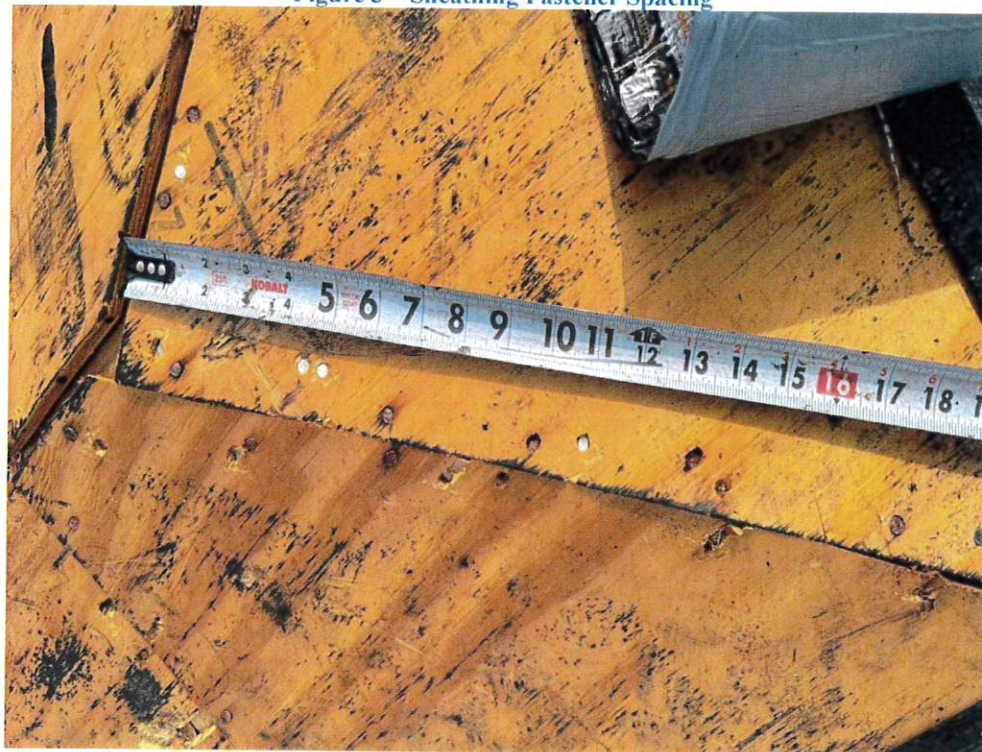
Figure 4 – Sheathing Edge Fastener Edge Spacing

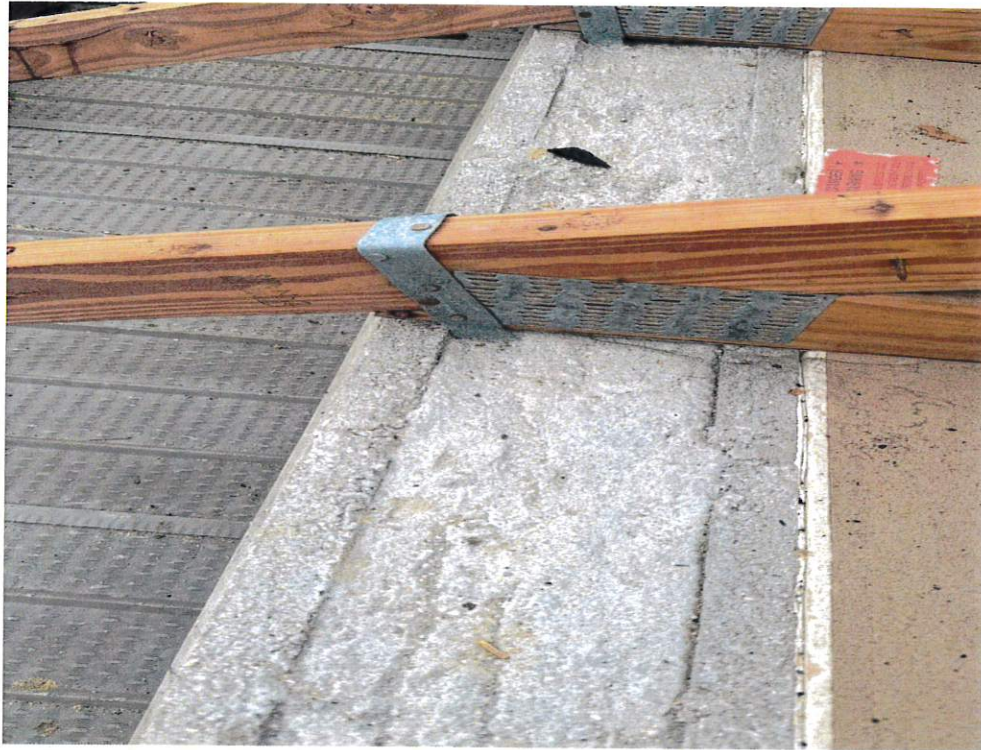
Figure 5 – Roof to Wall Attachment

- ☒ C. Single Wraps
  - Metal connectors consisting of a single strap that wraps over the top of the truss/rafter and is secured with a minimum of 2 nails on the front side and a minimum of 1 nail on the opposing side.

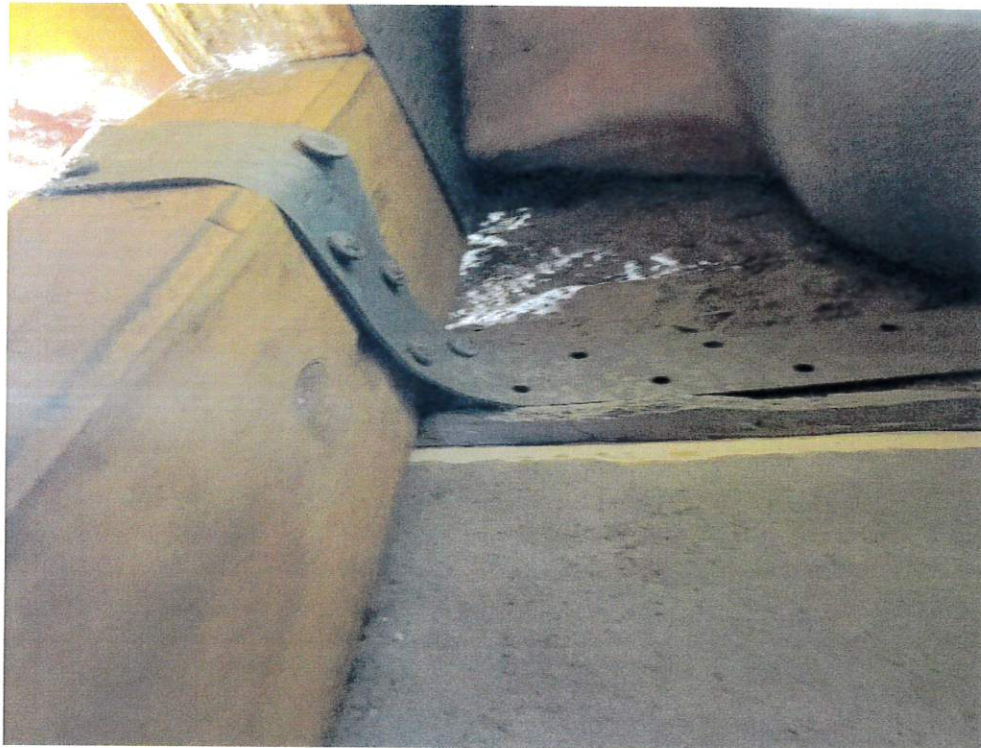
Figure 6 - Roof to Wall Attachment

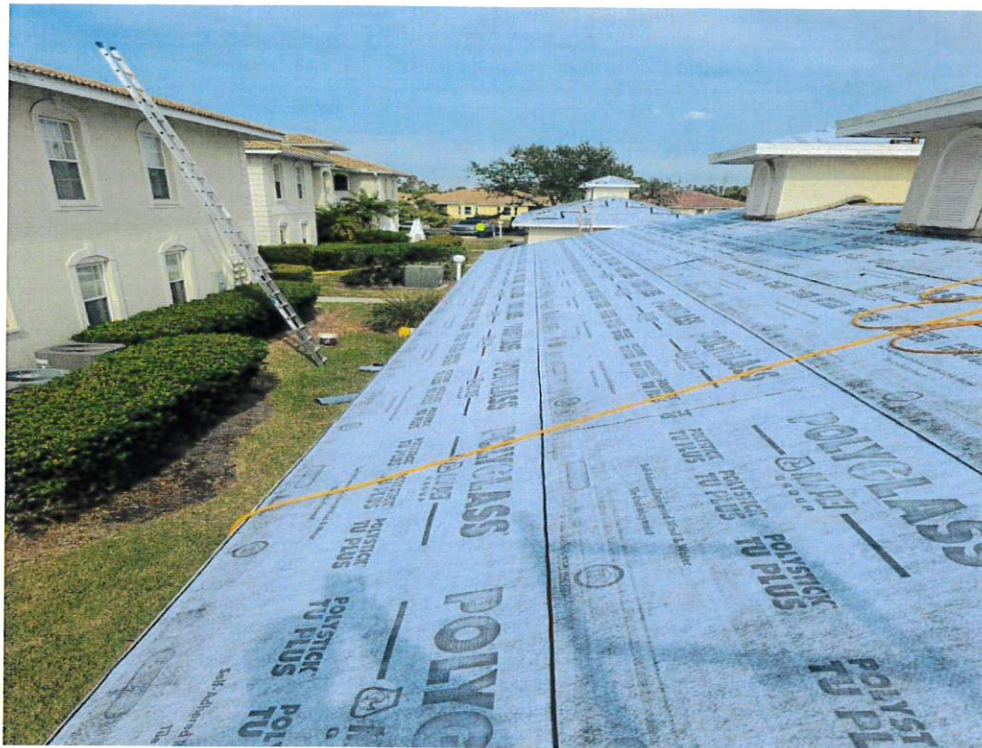
Figure 7 – Secondary Water Resistance

- ☒ A. SWR (also called Sealed Roof Deck) Self-adhering polymer modified-bitumen roofing underlayment applied directly to the sheathing or foam adhesive SWR barrier (not foamed-on insulation) applied as a supplemental means to protect the dwelling from water intrusion in the event of roof covering loss.
- ☐ B. No SWR.
- ☐ C. Unknown or undetermined.
