# Uniform Mitigation Verification Inspection Form

| Inspection Date: 12/7/2023 | | |
| Address: 875 Tartan Drive | | Home Phone: |

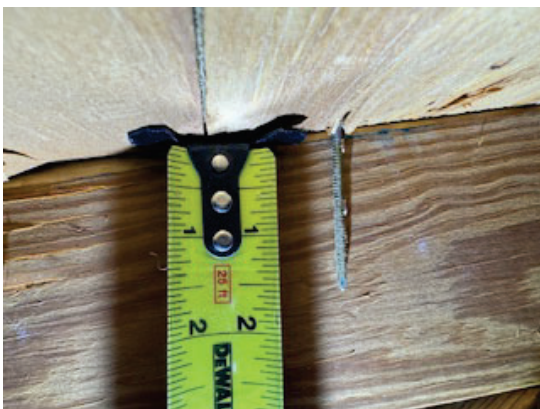
- ☒ C. Plywood/OSB roof sheathing with a minimum thickness of 7/16" inch attached to the roof truss/rafter (spaced a maximum of 24" inches o.c.) by 8d common nails spaced a maximum of 6" inches in the field. -OR- Dimensional lumber/Tongue & Groove decking with a minimum of 2 nails per board (or 1 nail per board if each board is equal to or less than 6 inches in width). -OR-

Nails

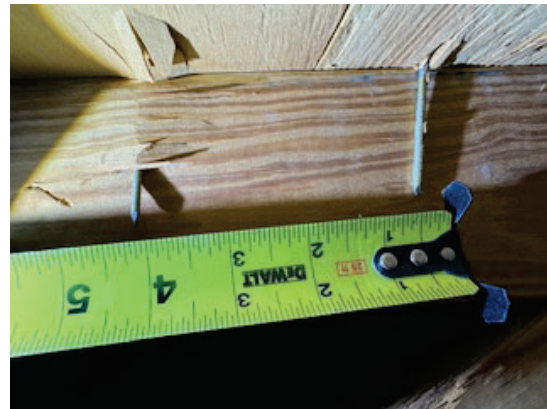
Nailing Pattern

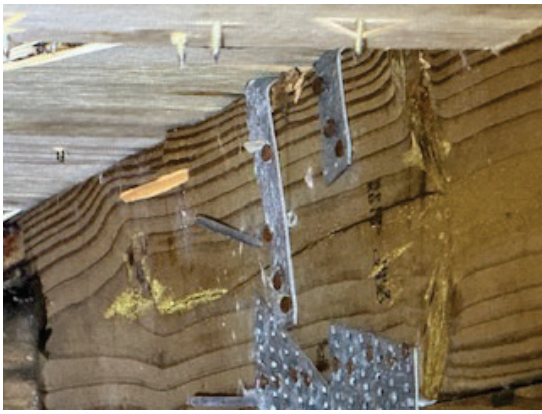
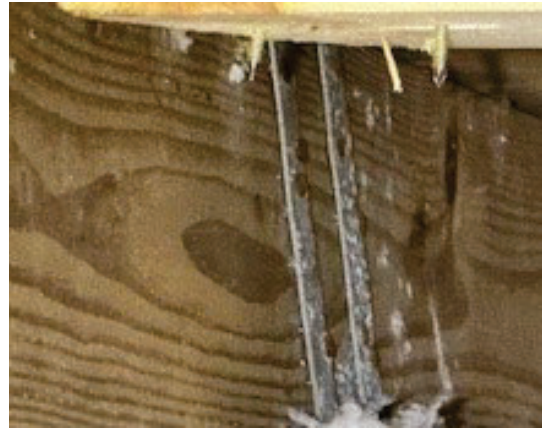
- ☒ Secured to truss/rafter with a minimum of three (3) nails, **and**
- ☒ Attached to the wall top plate of the wall framing, or embedded in the bond beam, with less than a ½" gap from the blocking or truss/rafter **and** blocked no more than 1.5" of the truss/rafter, **and** free of visible severe corrosion.

- ☒ C. Single Wraps
  - Metal connectors consisting of a single strap that wraps over the top of the truss/rafter and is secured with a minimum of 2 nails on the front side and a minimum of 1 nail on the opposing side.

Roof to Wall: Wrap with 3+ Nails
