Wind Mitigation Inspection Certificate

01/26/2023
Inspection Date

Golfvista Condominium Association
Homeowner

934 Capri Isles Blvd
Street Address

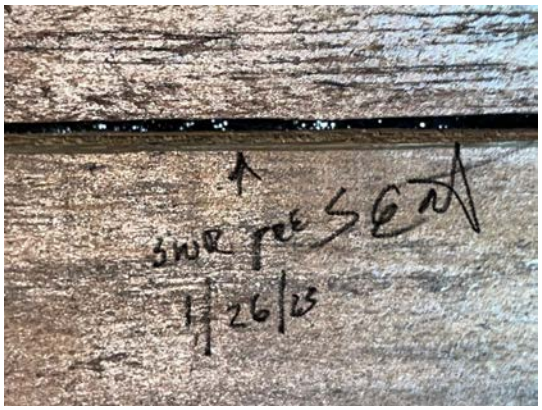
15/32" Roof Decking
